Attachment No. 5 – Final Walkthrough Punch List/ Inspection Report

CITY OF LAREDO UTILITIES DEPARTMENT JEFFERSON ST. WTP CHLORINE FEED IMPROVEMENTS FINAL WALKTHROUGH

DATE: March 14, 2024

CLIENT: City of Laredo Utilities Department

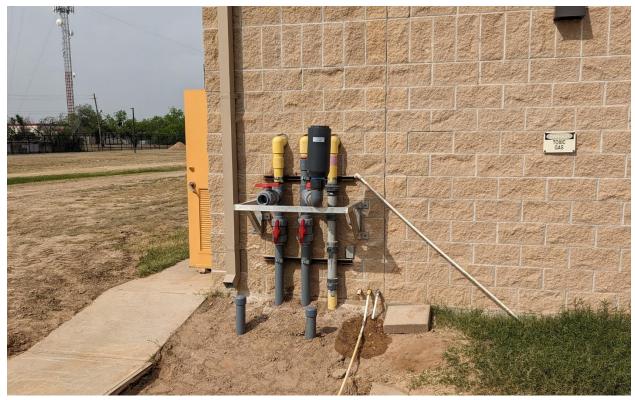
City has moved the ARV provided for the project to just outside the chlorine room. J.S. Haren
has provided cut sheet to Laredo to buy and install one themselves at high point as designed
in project.

Photo 1: Pipes outside of the chlorine room.

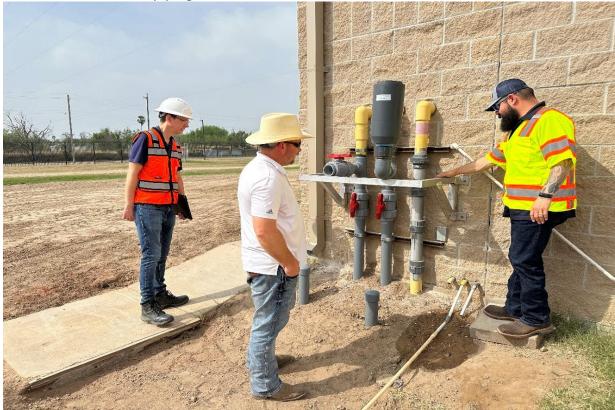
Photo 2: City, Ardurra, and J.S. Haren discussing outside piping connection at the chlorine room.

- Insulate all above ground piping per drawing note.
 - Note: pre-construction photos show point riser at raw water injection entirely insulated before this project. Contractor to re-apply insulation to existing piping as well as new piping.

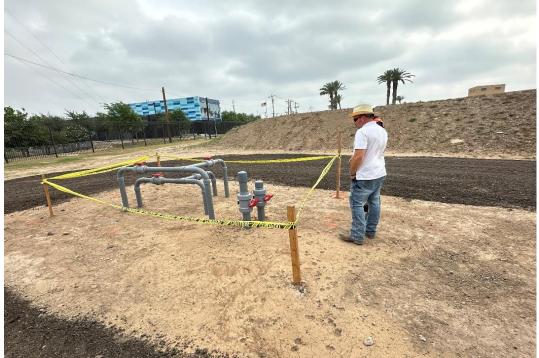
Photo 3: 3" Tee and reducer location, south view. (Refer to punch list item 3)

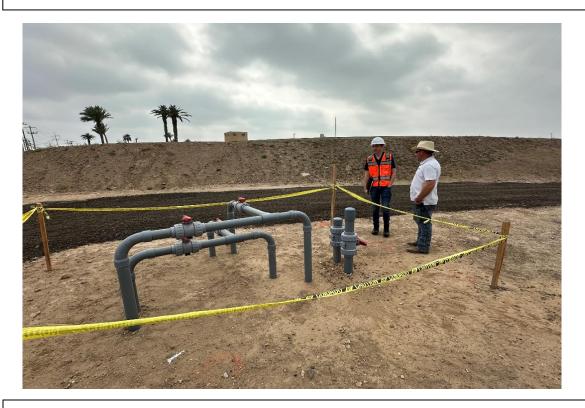
Photo 4: 3" Tee and reducer location, north view. (Refer to punch list item 3)

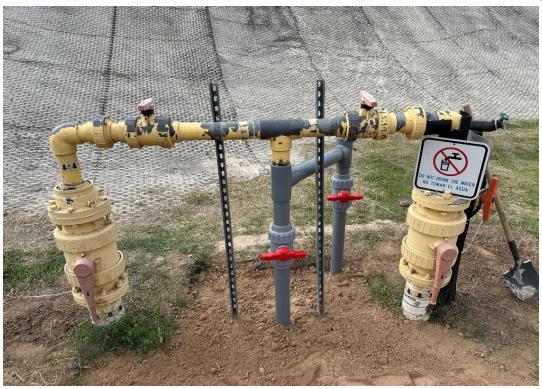
Photo 5: View of point riser. (Refer to punch list item 3)

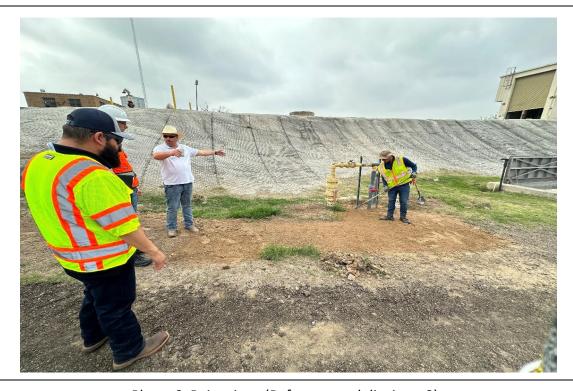
Photo 6: Point riser. (Refer to punch list item 3)

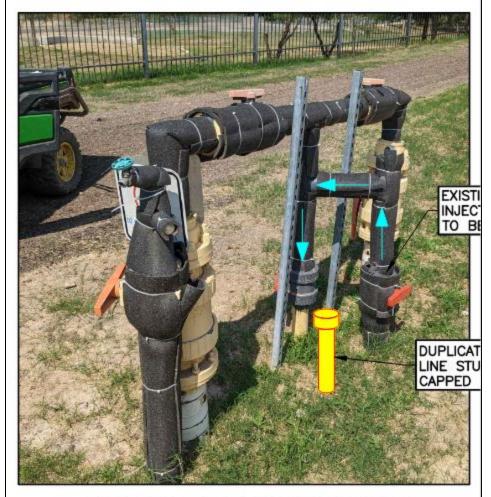
PHOTO B: INJECTION POINT RISER

<u>Photo 7</u>: Excerpt from Drawing Package Showing Piping At Raw Water Injection with Insulation Pre-Construction

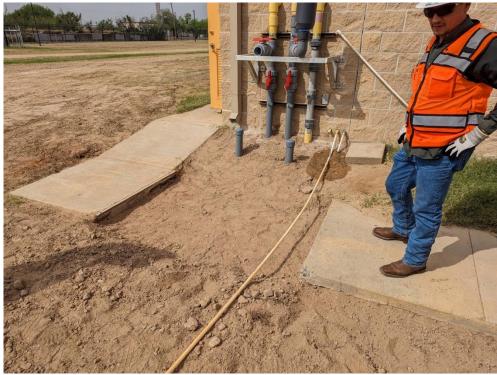
<u>Photo 8</u>: Contractor to replace sidewalk pavement at chemical building that was removed during construction (Refer to punch list item 4)

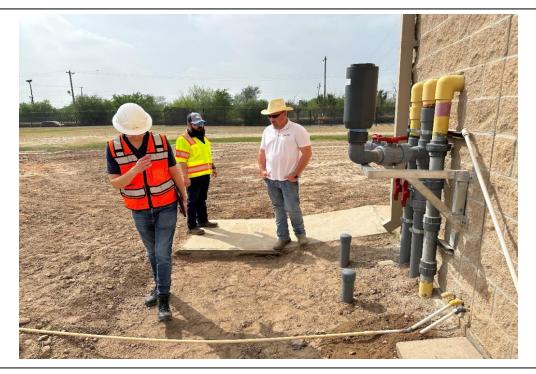
Photo 9: Sidewalk outside chemical building. (Refer to punch list item 4)

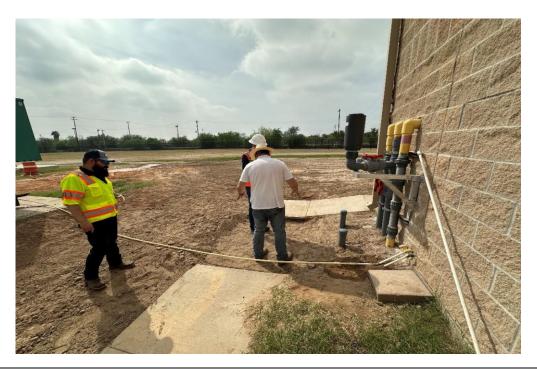
Photo 10: Line connection to chemical building, east view. (Refer to punch list item 3)

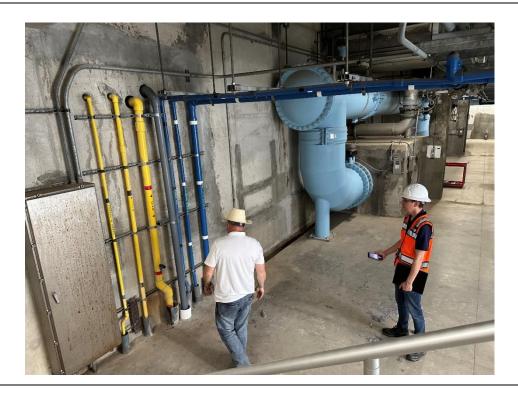
Photo 11: Line connection inside filters building ground level. (Refer to punch list item 5)

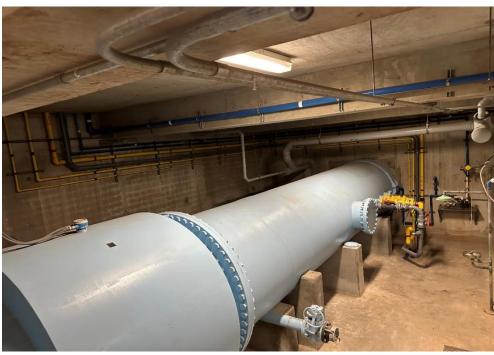
Photo 12: Line connection inside filters building lower level. (Refer to punch list item 5)

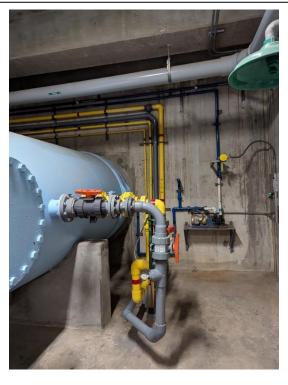
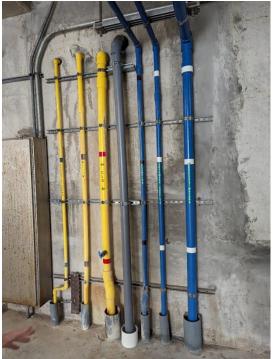
<u>Photos 13 and 14</u>: Contractor to provide labels/stickers for chemical piping inside filter building to City for placement. (Refer to punch list item 5)

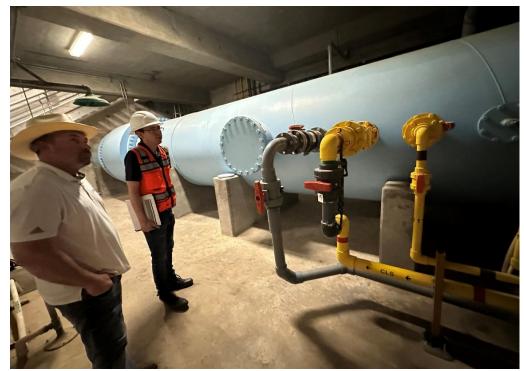
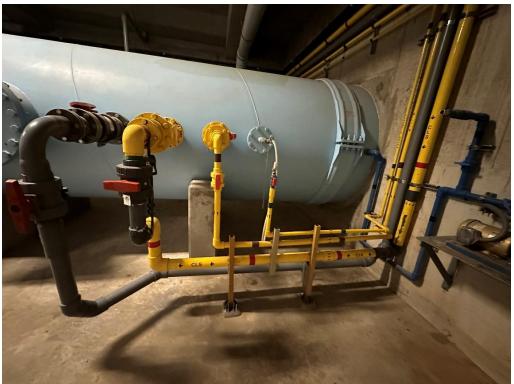
Photos 15 & 16: Tank connection. (Refer to punch list item 5)
