**TREMCO INCORPORATED
WEATHERPROOFING TECHNOLOGIES, INC.
ROOF ANALYSIS REPORT**

DATE: January 16, 2024

BUILDING: City of Laredo Utilities
5816 Daugherty
Laredo, TX 78041

ROOF AREA: MAIN ROOF

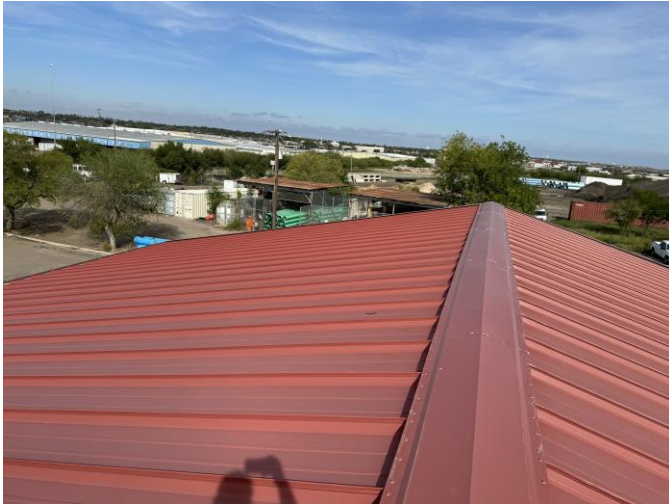
Overview of roof area.

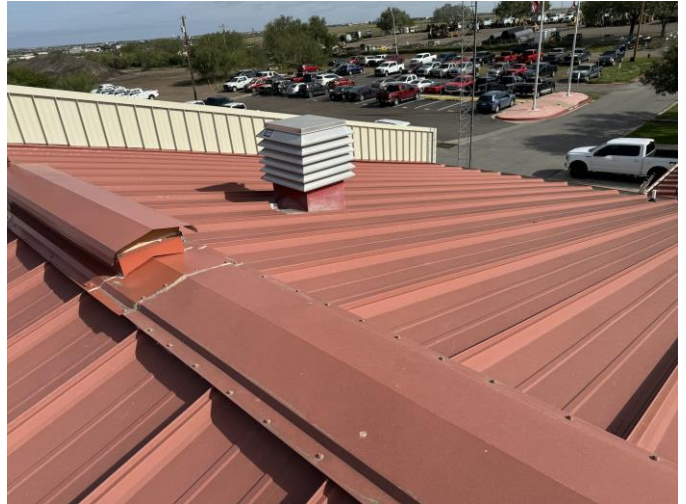
Overview of roof area.

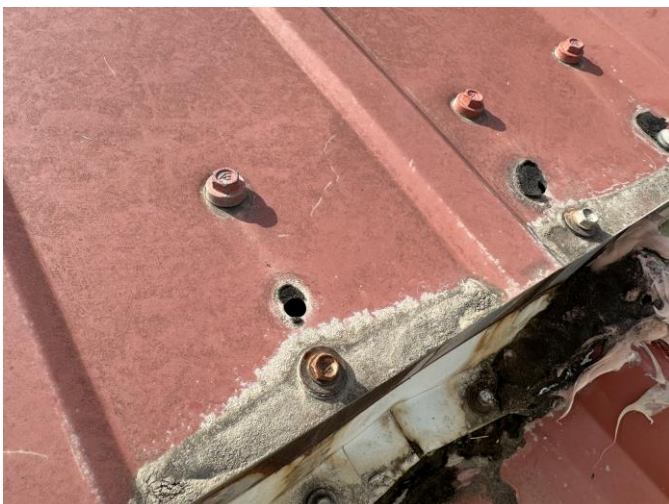
Missed or removed fasteners at eave. Note corrosion on fastener.

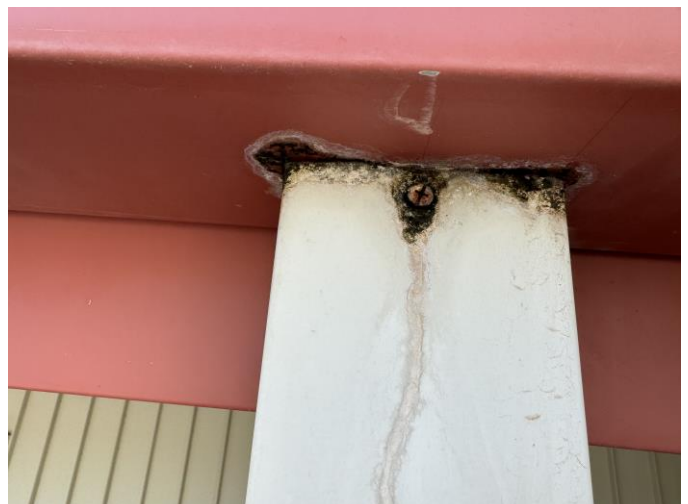
Corrosion at downspout connection.

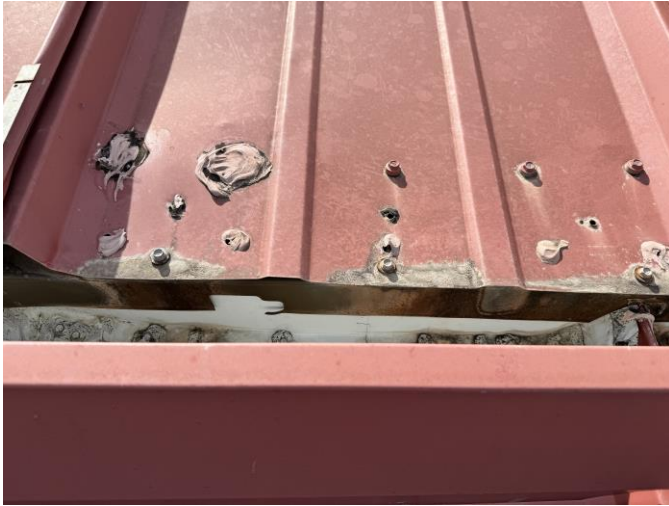
Multiple repairs or fastener holes at eave.

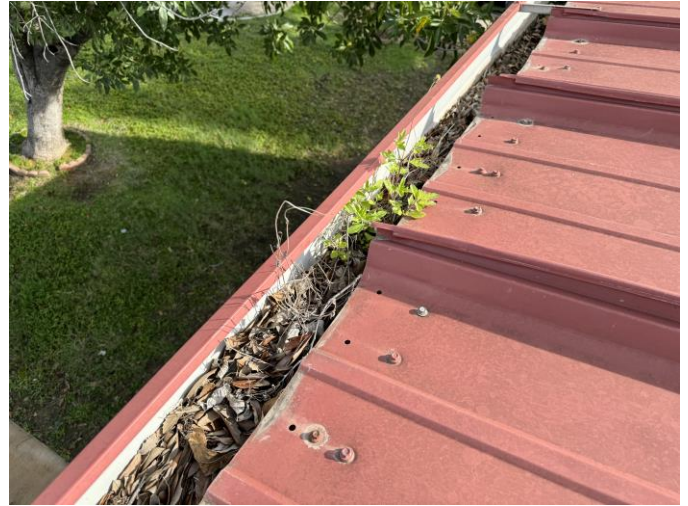
Trash and debris in gutter.

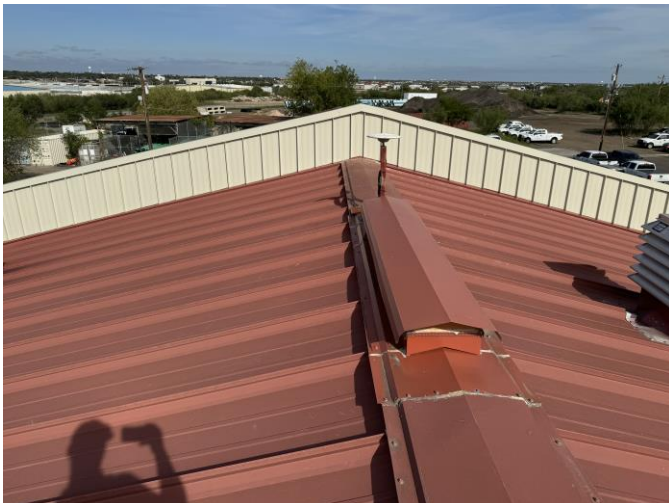
Rooftop vent locations are typical leak locations.

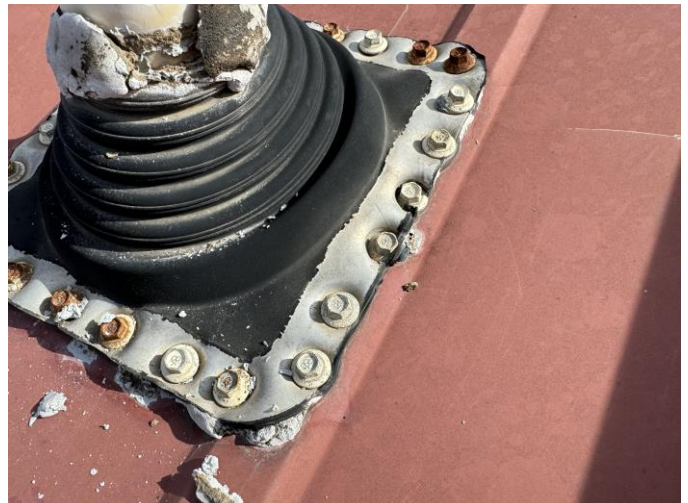
Vent pipe boot in poor condition.

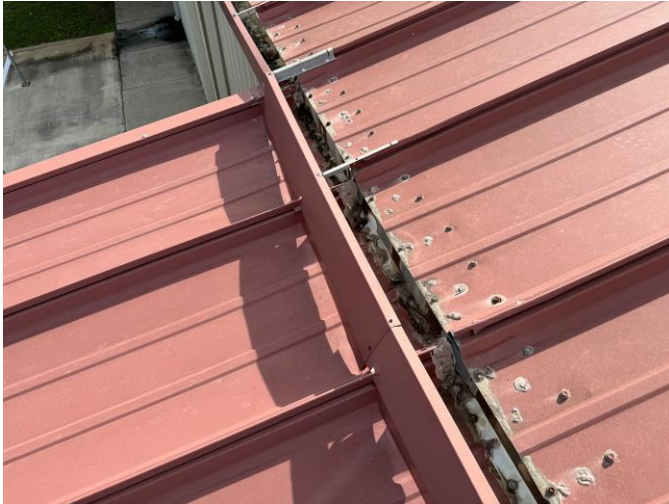
Trash and debris in gutter at roof transition.

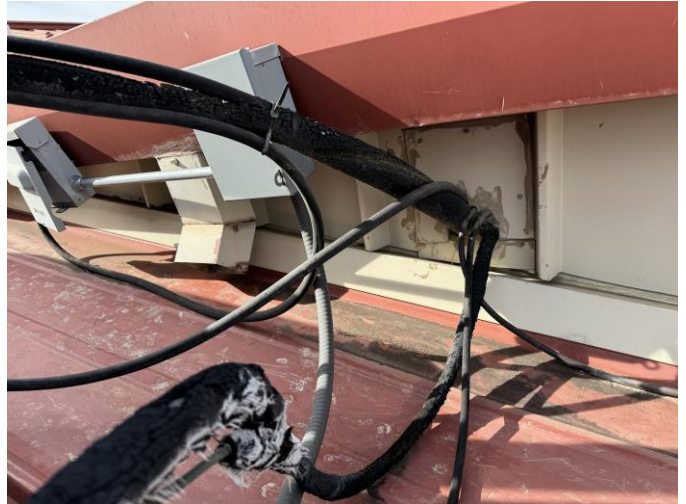
Electrical mounted to gutter.

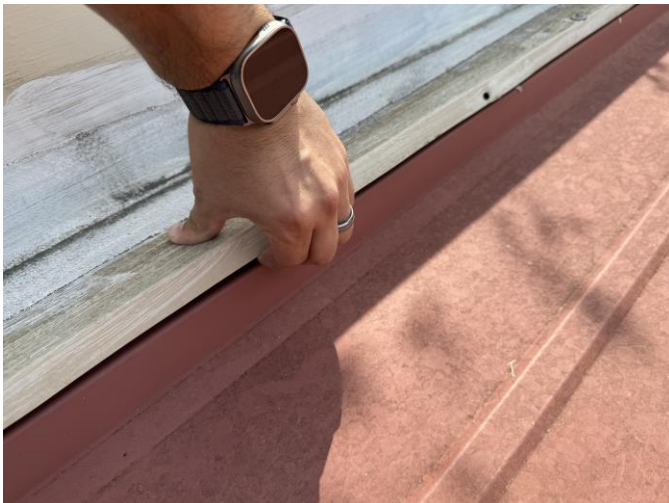
Poorly fastened flashing at wall intersection.

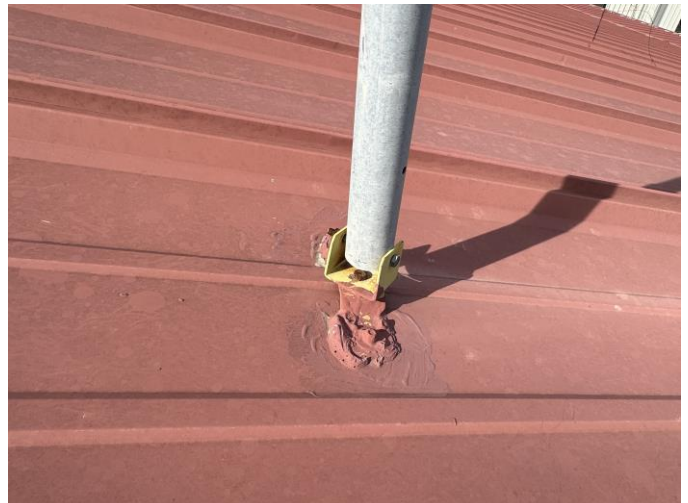
Missing flashing at pipe penetration.

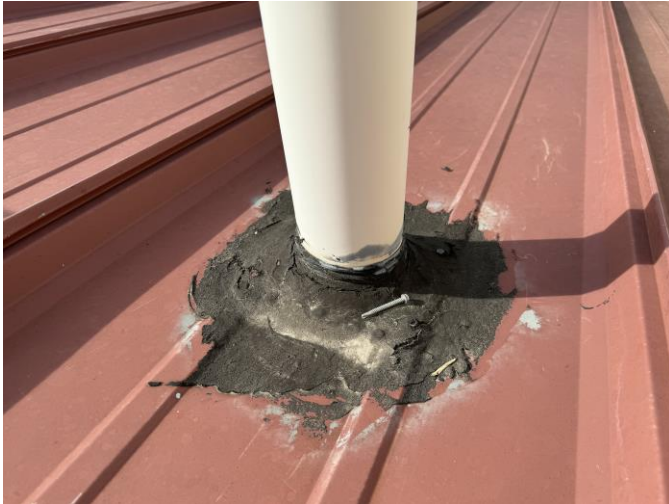
Poor flashing at pipe penetration.

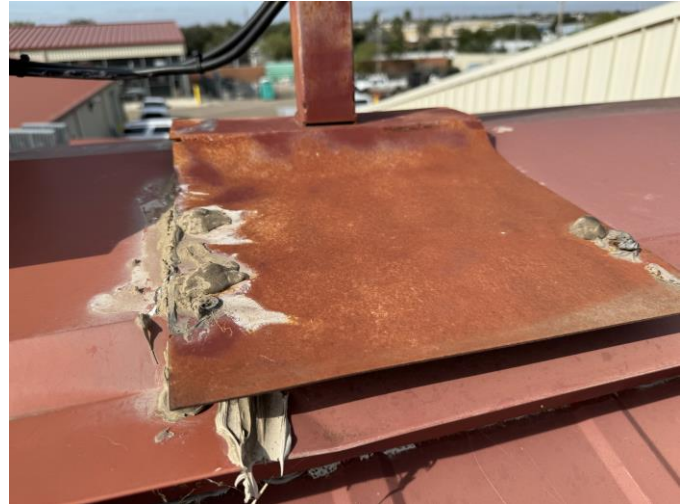
Poor flashing at ridge cap.

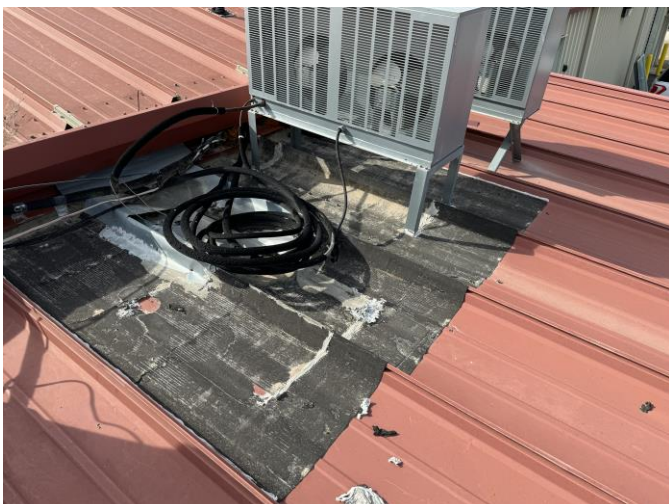
Repairs at lower roof.

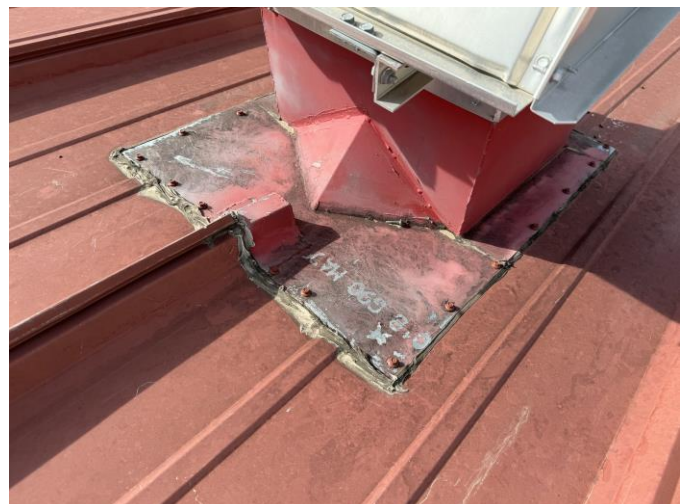
Repairs at vent locations.

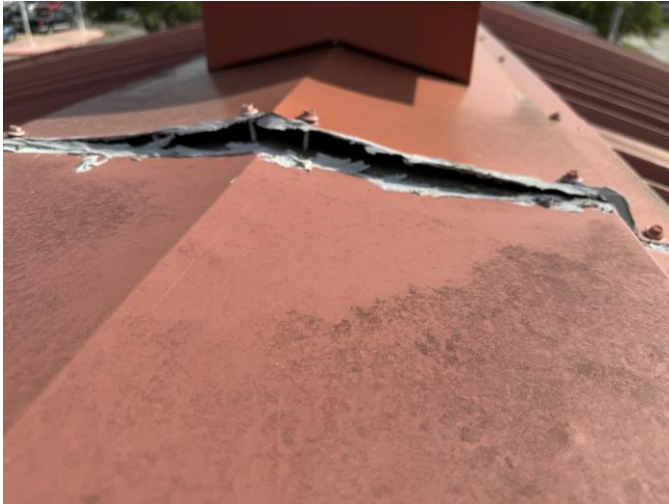
Open laps at ridge.

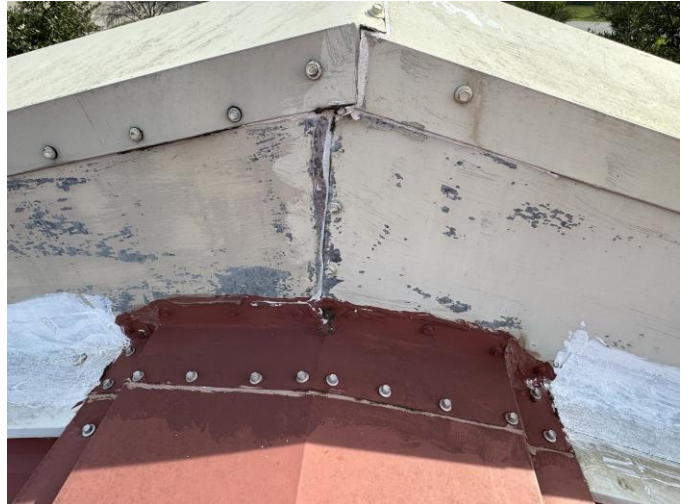
Open holes at wall intersection.

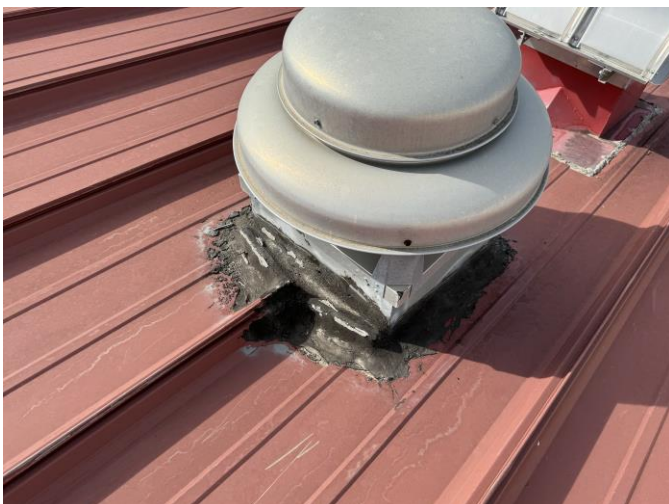
Repairs at roof vent location.

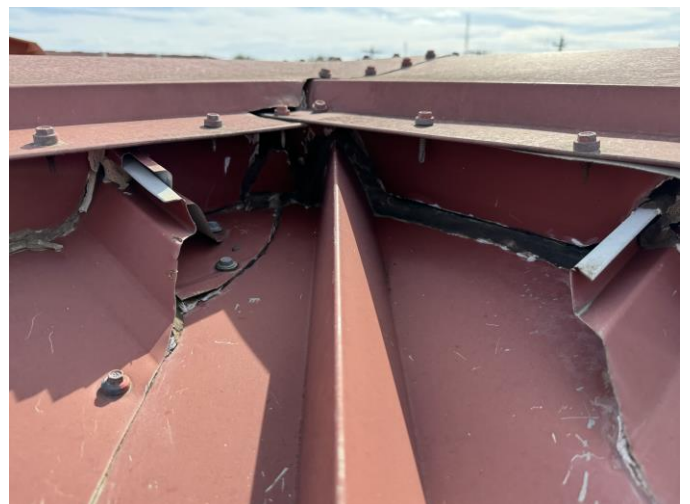
Open holes at laps and corners.
