PHOTOGRAPHIC DOCUMENTATION REPORT

Property: 305 San Bernardo Ave.

Date of Inspection: April 30, 2026.

Prepared By: Alejandra Martinez, Building Official

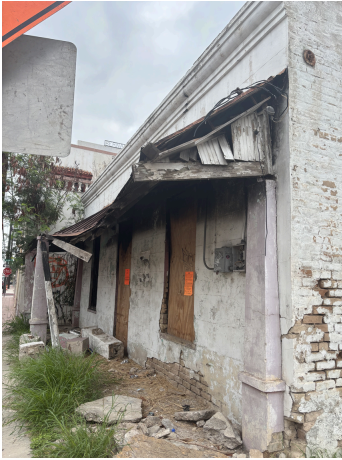
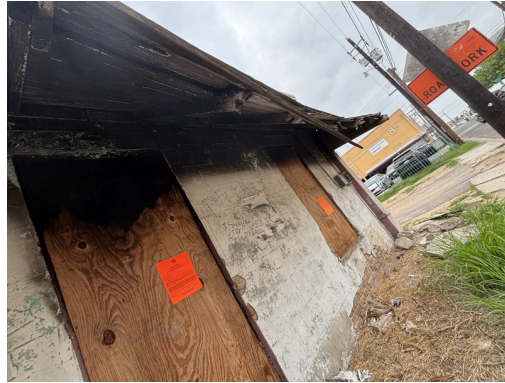
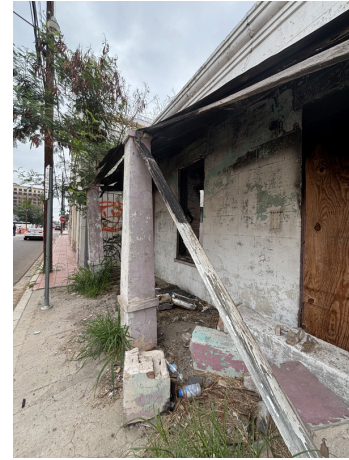
Front elevation – canopy failure

- Description: Front canopy exhibits severe structural distress with visible sagging and separation of structural members.
- Assessment: High risk of imminent collapse.

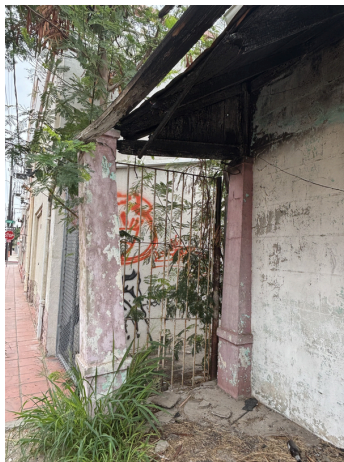
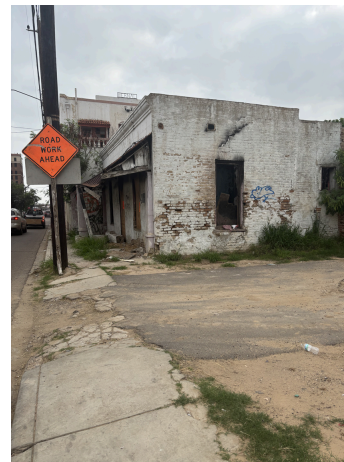
Sidewalk column hazard

- Description: Load-bearing column adjacent to public sidewalk shows instability and possible foundation compromise.
- Assessment: Direct hazard to pedestrians.

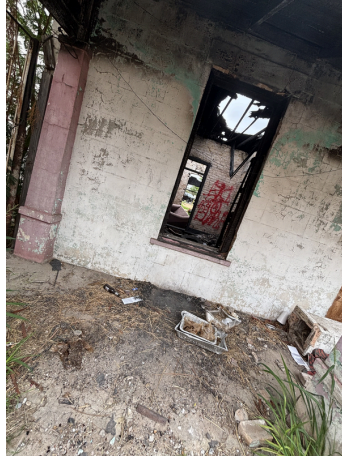
Interior roof deterioration

- Description: Interior roofing system exhibits extensive decay, moisture damage, and structural weakening.
- Assessment: Unsafe occupancy conditions.

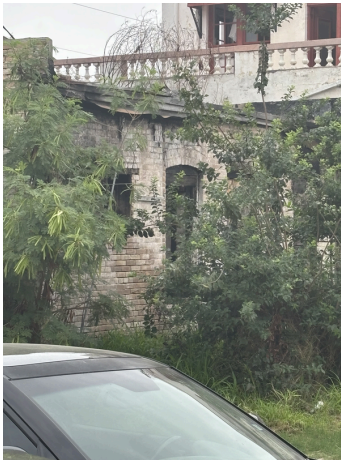
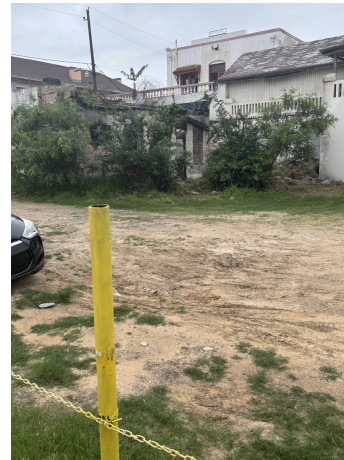
Rear structure condition
