# Santa Monica Parish Hall WINDOW STABILIZATION PROJECT

At former St. Augustine Parochial School, RTHL

Santa Monica Parish Hall  
Window Stabilization  
Laredo, Texas

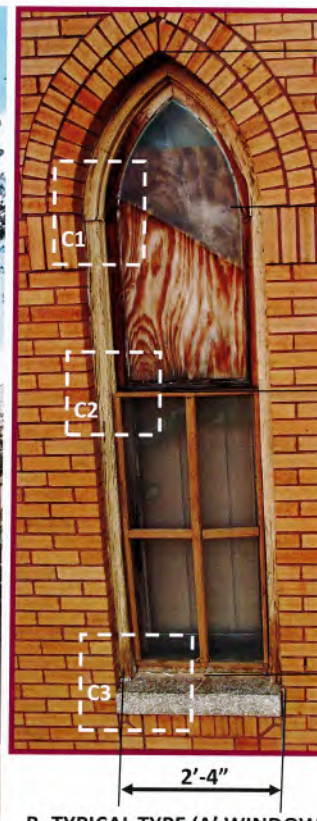
B. TYPICAL TYPE 'A' WINDOW  
AW301

1. WOOD FRAME: SHRINKING, SEPERATION & CRACKING. COMMON CAUSE OF MOISURE INFILTRATION, AIR LEAKS & STRUCTURAL INSTABILITY.
2. UPPER SASH: BOTTOM RAIL SEVERE DETERIORATION CAUSED LOSS OF GLAZING SUPPORT & GLASS PANE TO DROP OUT OF THE FRAME.

3. WOOD SILL: MOISTURE DETERIORATION CAUSING SHRINKING, SEPERATION, & STRUCTURAL INSTABILITY TO WINDOW FRAME.
4. BRICK COURSE (ARCH DOUBLE HEADER TO ROWLOCK, SOLDIER BAND AT SPRING POINT, ROWLOCK & MIDERED BRICKWORK BELOW CAST STONE SILL: COMMN MOISTURE INFILTRATION BEHIND BRICK, WOOD FRAME & CAUSE STRUCTURAL INSTABILITY. REQUIRE REPOINTING & CONTINUOUS WATERPROOFING AT WINDOW.

5. GLASS PANE & GLAZING: DAMAGE, DETERIORATED, NEEDS REPLACEMENT OF GLASS & CONTINUOUS GLAZING.
6. MISSING HISTORIC FABRIC: REFABRICATE WITH MATCHING MATERIAL SUCH AS LONGLEAF PINE (AS PER MATERIAL TEST)

7. NON-HISTORIC HALF WOOD SCREEN: REMOVE.
8. PROVIDE SHOP DRAWINGS FOR ALL REPAIRS, VERIFY DIMENSIONS AND SITE CONDITIONS, IDENTIFY SCOPE OF REHABILITATION OF WINDOWS INCLUDING ITEMS BEYOND REPAIR REQUIRING RECONSTRUCTION. IDENTIFY THERMAL AND MOISTURE PROTECTION FOR WINDOW INSTALLATIONS TO EXISTING OPENINGS.

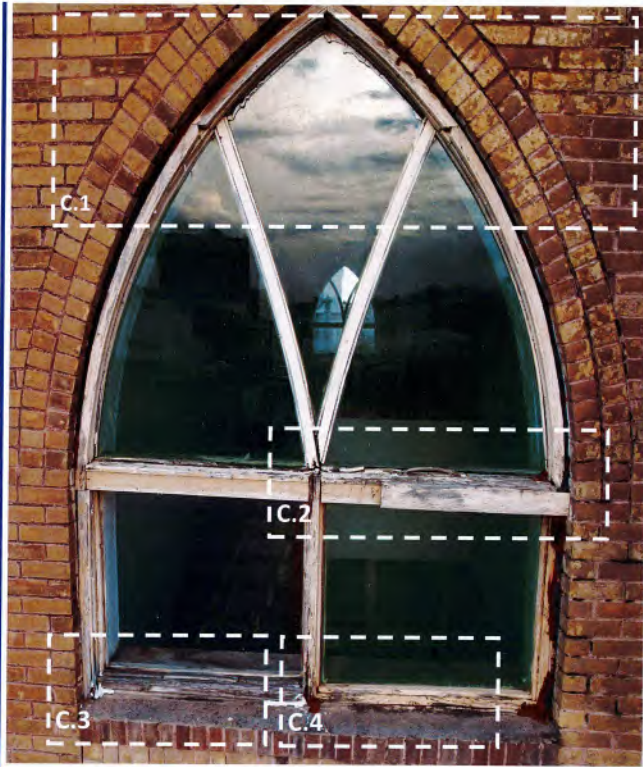
**A. NORTH ELEVATION — TYPE 'G' WINDOW - GN301**

1. WOOD FRAME: SHRINKING, SEPERATION & CRACKING.
2. N/A
3. WOOD SILL: MOISTURE DETERIORATION
4. BRICK COURSE MOISTURE INFILTRATION
5. GLASS PANE & GLAZING: DETERIORATED
6. MISSING HISTORIC FABRIC (MATERIAL TEST)
7. N/A
8. PROVIDE SHOP DRAWINGS

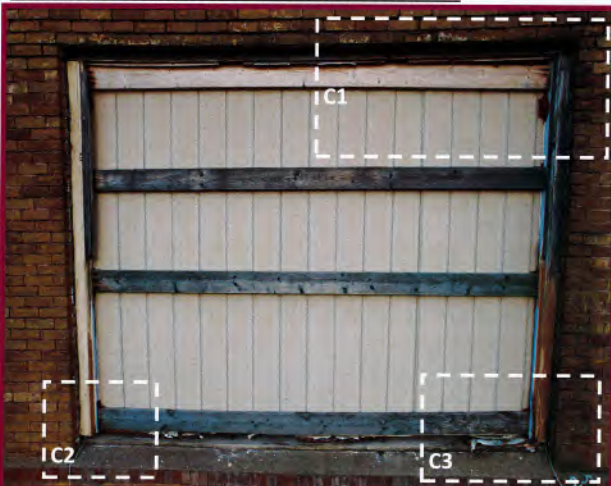
B. NORTH TYPE 'E' WINDOW SET — EN304

TYPE 'E1' IS ONE (1) OF 12 SETS OF THREE (3) DOUBLE HUNG WINDOWS WITH SIX OVER SIX (6/6) LITES LOCATED ON THE NORTH ELEVATIONS. THESE TWELVE (12) ARE THE MOST CRITICALLY DAMAGED WINDOWS FOUND ON THE 1927 BUILDING. UNFORTUNETLY, FOUR (4) OF SIX (6) SETS LOCATED AT THE THIRD (3RD) FLOOR ARE **SEVERLY COMPROMISED BEYOND REPAIR** TO EFFECTIVELY PERFORM ALL THE FUNCTIONS OF THE WINDOW WHILE ONE (1) SET (EN304) IS COMPLETELY MISSING. WHILE THE FOLLOWING PAGES WILL REVIEW EACH SET, IT SHOULD BE SUMMARIZED THAT THE SAME WINDOWS EXPOSED TO THE SOUTH WEATHER WOULD HAVE BEEN WORSE IF NOT PROTECTED BY THE ADJOINING CATHEDRAL STRUCTURE. WE RECOMMEND SALVAGING ANY COMPONENTS TO RESTORE THE TYPE 'E' SETS ON THE SOUTH ELEVATION OVER THOSE ON THE NORTH ELEVATION.

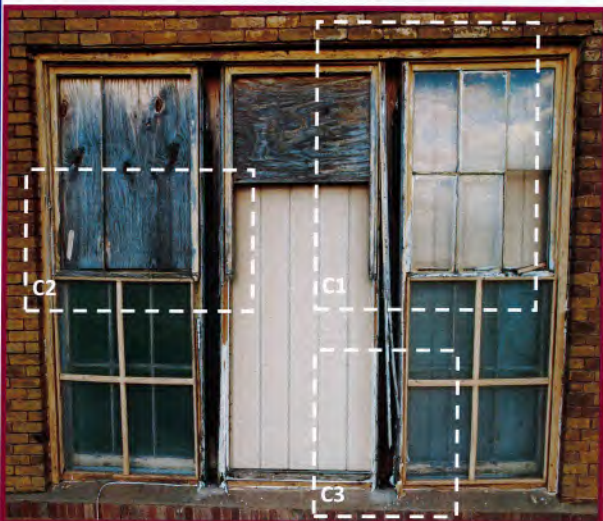
B. NORTH TYPE 'E' WINDOW SET — EN303

TYPE 'E2' — EN303 IS ONE (1) OF THE FOUR (4) SETS OF TYPE 'E' WINDOWS AT THE (3RD) FLOOR WHICH ARE **SEVERLY COMPROMISED BEYOND REPAIR** TO EFFECTIVELY PERFORM ALL THE FUNCTIONS OF THE WINDOW. WE RECOMMEND SALVAGING ITS COMPONENTS TO RESTORE THE TYPE 'E' SETS ON SOUTH ELEVATION OVER THOSE ON THE NORTH.

1. WOOD FRAME: SHRINKING, SEPERATION & CRACKING CAUSE OF MOISURE INFILTRATION, AIR LEAKS & STRUCTURAL INSTABILITY.
2. UPPER SASH: BOTTOM RAIL'S SEVERE DETERIORATION CAUSED LOSS OF GLAZING SUPPORT & GLASS PANE TO DROP OF THE FRAME

3. WOOD SILL: MOISTURE DETERIORATION CAUSING SHRINKING, SEPERATION, & STRUCTURAL INSTABILITY TO WINDOW FRAME.
4. BRICK COURSE: COMMN MOISTURE INFILTRATION BEHIND BRICK, WOOD FRAME & CAUSE OF STRUCTURAL INSTABILITY. REQUIRE REPOINTING & CONTINUOUS WATERPROOFING AT WINDOW

5. GLASS PANE & GLAZING: DAMAGE, DETERIORATED, NEEDS REPLACEMENT OF GLASS & CONTINUOUS GLAZING.
6. MISSING HISTORIC FABRIC: REFABRICATE WITH MATCHING MATERIAL SUCH AS LONGLEAF PINE, PER MATERIAL TEST

7. NON-HISTORIC HALF WOOD SCREEN: REMOVE.
8. PROVIDE SHOP DRAWINGS FOR ALL REPAIRS, VERIFY DIMENSIONS AND SITE CONDITIONS, IDENTIFY SCOPE OF REHABILITATION OF WINDOWS INCLUDING ITEMS BEYOND REPAIR REQUIRING RECONSTRUCTION. IDENTIFY THERMAL AND MOISTURE PROTECTION FOR WINDOW INSTALLATIONS TO EXISTING OPENINGS.

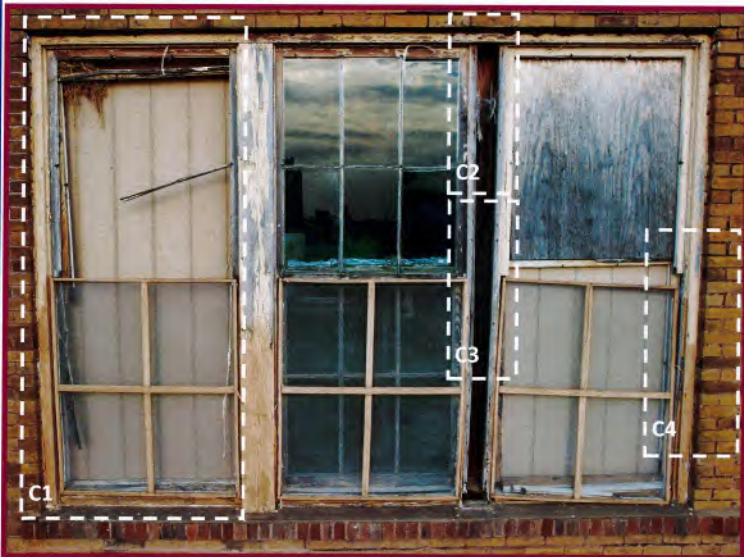
B. NORTH TYPE 'E' WINDOW SET — EN301

TYPE 'E3' — EN301 IS ONE (1) OF THE FOUR (4) SETS OF TYPE 'E' WINDOWS AT THE (3RD) FLOOR WHICH ARE **SEVERLY COMPROMISED BEYOND REPAIR** TO EFFECTIVELY PERFORM ALL THE FUNCTIONS OF THE WINDOW. WE RECOMMEND SALVAGING ITS COMPONENTS TO RESTORE THE TYPE 'E' SETS ON THE SOUTH ELEVATION OVER THOSE ON THE NORTH ELEVATION.

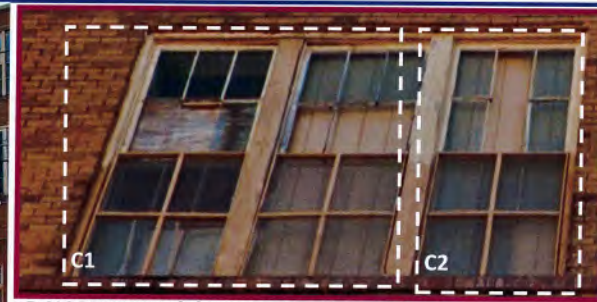
B. NORTH TYPE 'E' WINDOW SET — EN302

TYPE 'E3' — EN302 IS ONE (1) OF THE FOUR (4) SETS OF TYPE 'E' WINDOWS AT THE (3RD) FLOOR WHICH ARE **SEVERLY COMPROMISED BEYOND REPAIR** TO EFFECTIVELY PERFORM ALL THE FUNCTIONS OF THE WINDOW. WE RECOMMEND SALVAGING ITS COMPONENTS TO RESTORE THE TYPE 'E' SETS ON THE SOUTH ELEVATION OVER THOSE ON THE NORTH ELEVATION.

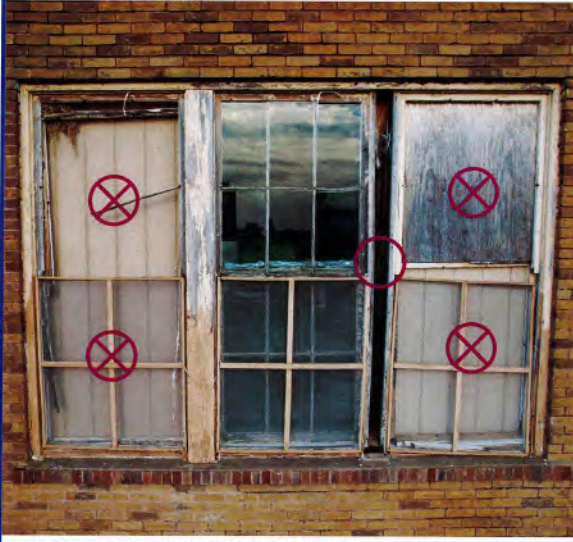
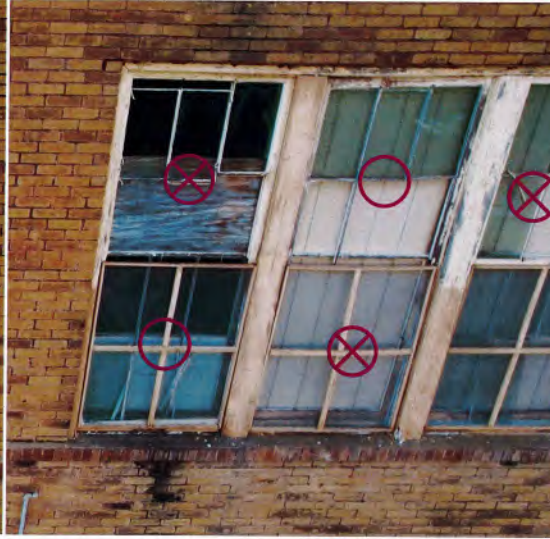
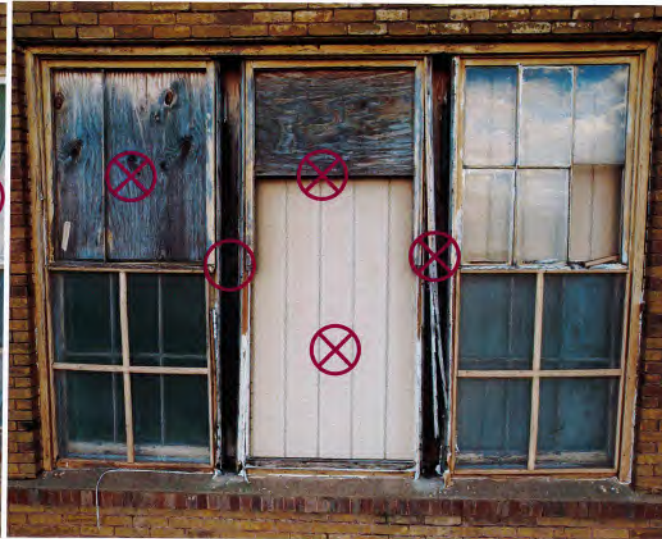
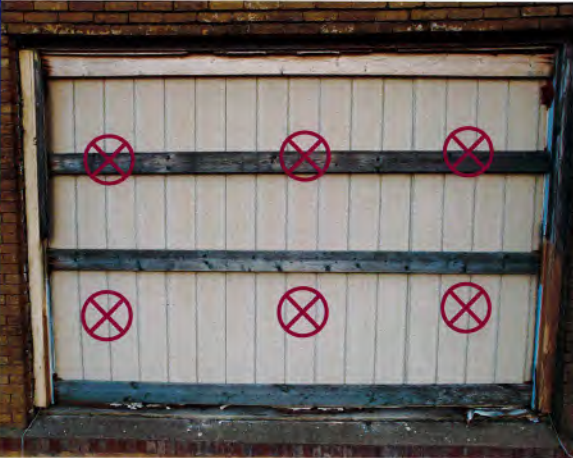
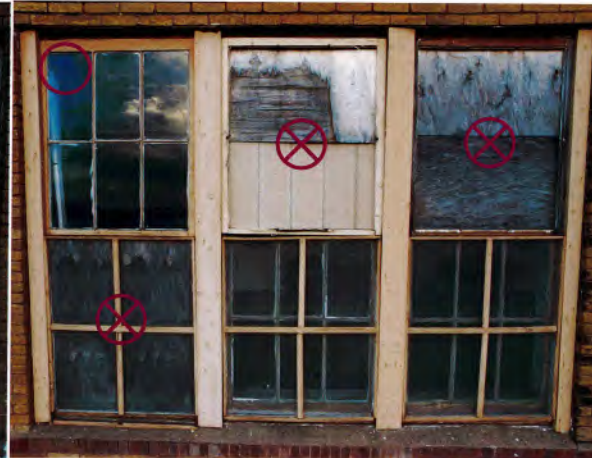
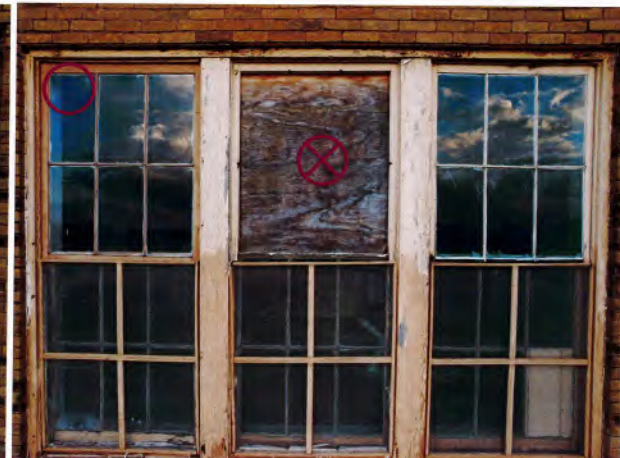
SUMMARY OF NORTH TYPE 'E' WINDOW SETS AT 3RD FLOOR: SEVER DAMAGE AT MAJORITY OF THE SETS AND MAJORITY OF THE 18 DH UNITS.

SINCE SOUTH TYPE 'E' ARE IN BETTER CONDITIONS HAVING HAD BETTER PROTECTION FROM THE WEATHER, THEN SALVAGED MATERIAL COULD BE USED FOR THEIR RESTORATION.

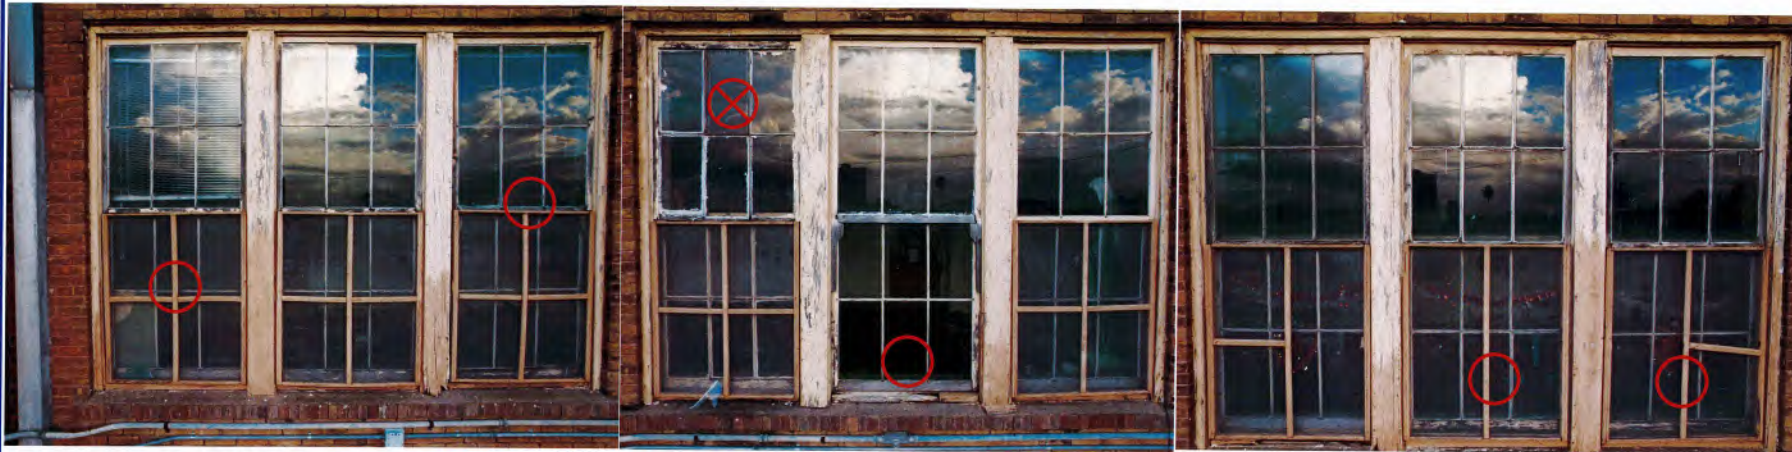
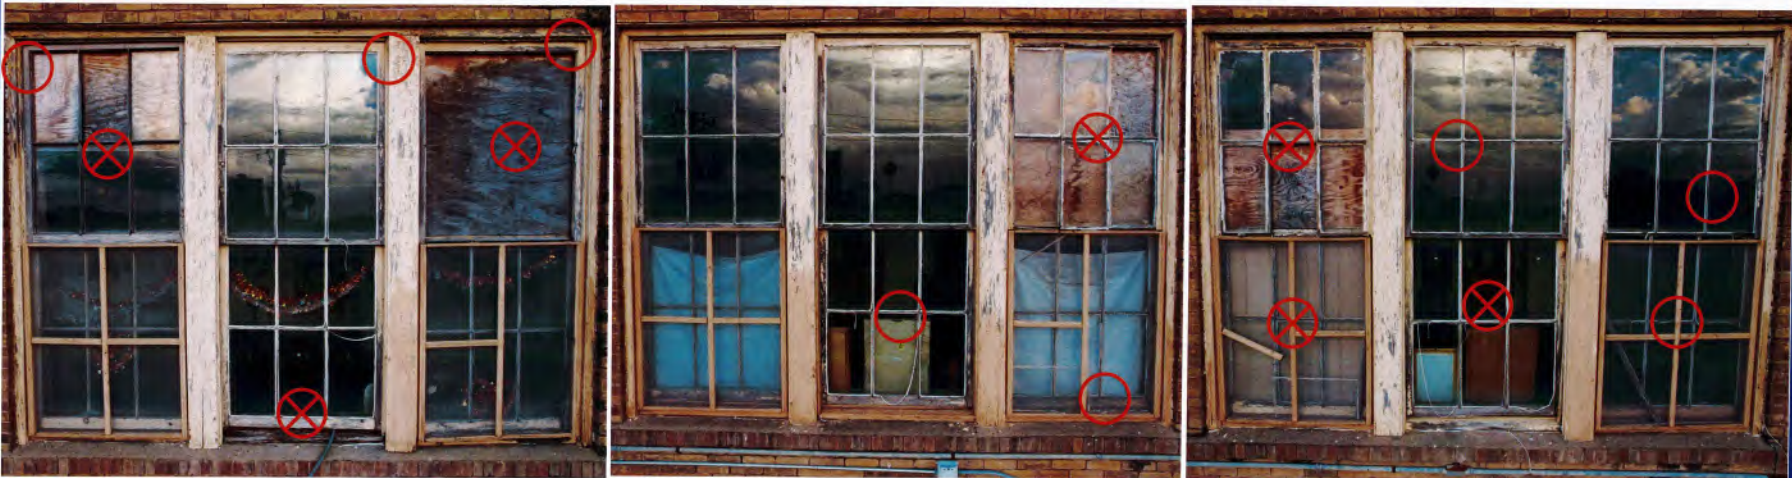
SUMMARY OF NORTH TYPE 'E' WINDOW SETS AT 2ND FLOOR: ASSORTMENT OF DAMAGE, TEMPORARY REPAIR FAILURE & MOISTURE INFILTRATION AT MAJORITY OF THE SETS AND MOST OF THE 18 DH UNITS. ADDITIONAL INVESTIGATION, WINDOW SITE SURVEY & TESTING RECOMMENDED PRIOR TO RESTORATION AND/OR CONTINUED MIDIGATION.
