# Santa Monica Parish Hall WINDOW STABILIZATION PROJECT

At former St. Augustine Parochial School, RTHL

Santa Monica Parish Hall  
Window Stabilization  
Laredo, Texas

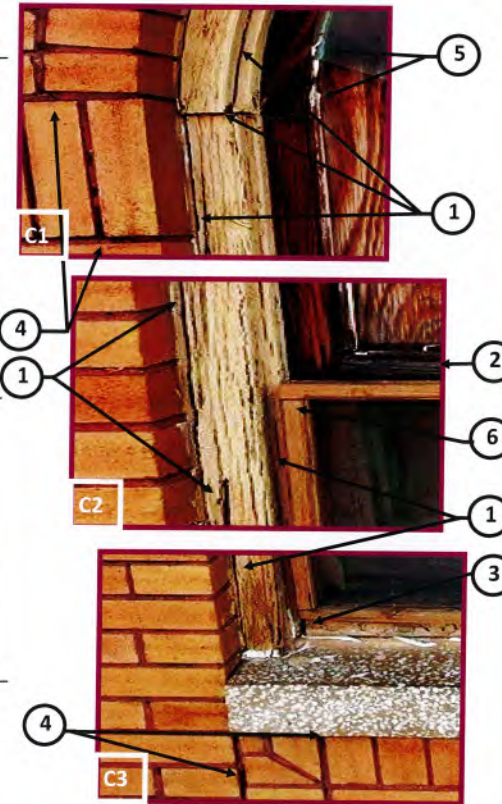
C. WINDOW DETAILS (SPRING JOINT, JAMB, SILL)

1. WOOD FRAME: SHRINKING, SEPERATION & CRACKING. COMMON CAUSE OF MOISURE INFILTRATION, AIR LEAKS & STRUCTURAL INSTABILITY.
2. UPPER SASH: BOTTOM RAIL SEVERE DETERIORATION CAUSED LOSS OF GLAZING SUPPORT & GLASS PANE TO DROP OUT OF THE FRAME.

3. WOOD SILL: MOISTURE DETERIORATION CAUSING SHRINKING, SEPERATION, & STRUCTURAL INSTABILITY TO WINDOW FRAME.
4. BRICK COURSE (ARCH DOUBLE HEADER TO ROWLOCK, SOLDIER BAND AT SPRING POINT, ROWLOCK & MIDERED BRICKWORK BELOW CAST STONE SILL: COMMN MOISTURE INFILTRATION BEHIND BRICK, WOOD FRAME & CAUSE STRUCTURAL INSTABILITY. REQUIRE REPOINTING & CONTINUOUS WATERPROOFING AT WINDOW.

5. GLASS PANE & GLAZING: DAMAGE, DETERIORATED, NEEDS REPLACEMENT OF GLASS & CONTINUOUS GLAZING.
6. MISSING HISTORIC FABRIC: REFABRICATE WITH MATCHING MATERIAL SUCH AS LONGLEAF PINE (AS PER MATERIAL TEST)

7. NON-HISTORIC HALF WOOD SCREEN: REMOVE.
8. PROVIDE SHOP DRAWINGS FOR ALL REPAIRS, VERIFY DIMENSIONS AND SITE CONDITIONS, IDENTIFY SCOPE OF REHABILITATION OF WINDOWS INCLUDING ITEMS BEYOND REPAIR REQUIRING RECONSTRUCTION. IDENTIFY THERMAL AND MOISTURE PROTECTION FOR WINDOW INSTALLATIONS TO EXISTING OPENINGS.

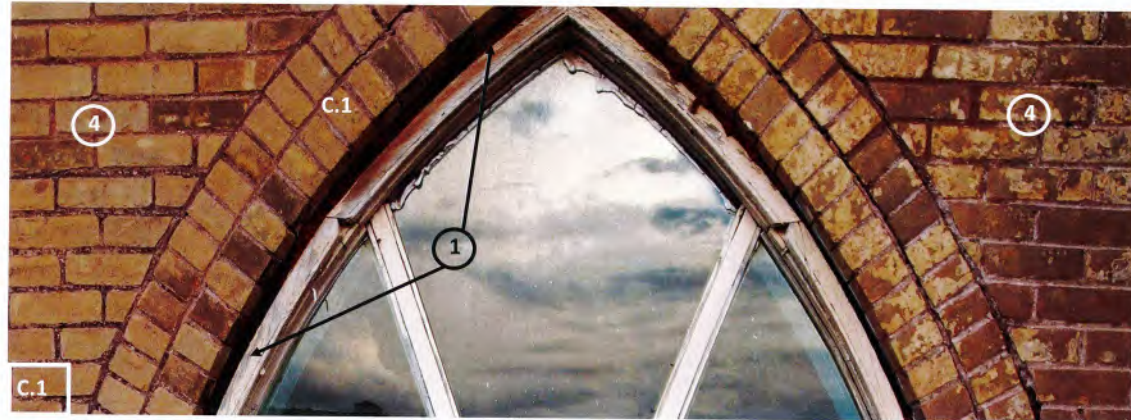
1. WOOD FRAME: SHRINKING, SEPERATION & CRACKING.
2. N/A
3. WOOD SILL: MOISTURE DETERIORATION
4. BRICK COURSE MOISTURE INFILTRATION
5. GLASS PANE & GLAZING: DETERIORATED
6. MISSING HISTORIC FABRIC (MATERIAL TEST)
7. N/A
8. PROVIDE SHOP DRAWINGS

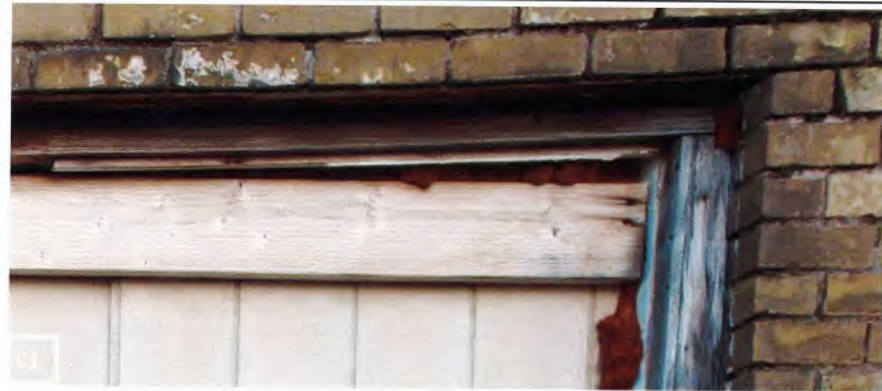
B. NORTH TYPE 'E' WINDOW SET — EN304

TYPE 'E1' IS ONE (1) OF 12 SETS OF THREE (3) DOUBLE HUNG WINDOWS WITH SIX OVER SIX (6/6) LITES LOCATED ON THE NORTH ELEVATIONS. THESE TWELVE (12) ARE THE MOST CRITICALLY DAMAGED WINDOWS FOUND ON THE 1927 BUILDING. UNFORTUNETLY, FOUR (4) OF SIX (6) SETS LOCATED AT THE THIRD (3RD) FLOOR ARE **SEVERLY COMPROMISED BEYOND REPAIR** TO EFFECTIVELY PERFORM ALL THE FUNCTIONS OF THE WINDOW WHILE ONE (1) SET (EN304) IS COMPLETELY MISSING. WHILE THE FOLLOWING PAGES WILL REVIEW EACH SET, IT SHOULD BE SUMMARIZED THAT THE SAME WINDOWS EXPOSED TO THE SOUTH WEATHER WOULD HAVE BEEN WORSE IF NOT PROTECTED BY THE ADJOINING CATHEDRAL STRUCTURE. WE RECOMMEND SALVAGING ANY COMPONENTS TO RESTORE THE TYPE 'E' SETS ON THE SOUTH ELEVATION OVER THOSE ON THE NORTH ELEVATION.

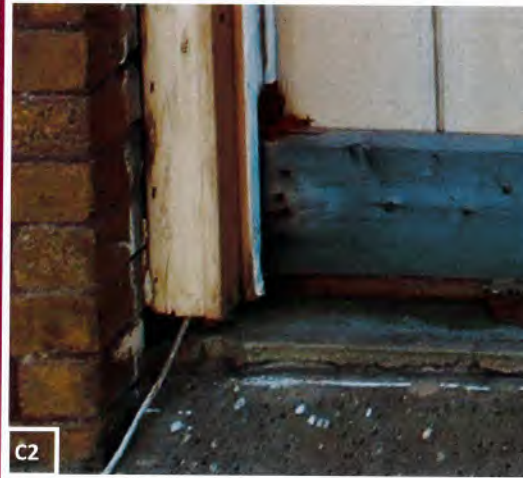
C2

1. WOOD FRAME: SHRINKING, SEPERATION & CRACKING CAUSE OF MOISURE INFILTRATION, AIR LEAKS & STRUCTURAL INSTABILITY.
2. UPPER SASH: BOTTOM RAIL'S SEVERE DETERIORATION CAUSED LOSS OF GLAZING SUPPORT & GLASS PANE TO DROP OF THE FRAME

3. WOOD SILL: MOISTURE DETERIORATION CAUSING SHRINKING, SEPERATION, & STRUCTURAL INSTABILITY TO WINDOW FRAME.
4. BRICK COURSE: COMMN MOISTURE INFILTRATION BEHIND BRICK, WOOD FRAME & CAUSE OF STRUCTURAL INSTABILITY. REQUIRE REPOINTING & CONTINUOUS WATERPROOFING AT WINDOW

5. GLASS PANE & GLAZING: DAMAGE, DETERIORATED, NEEDS REPLACEMENT OF GLASS & CONTINUOUS GLAZING.
6. MISSING HISTORIC FABRIC: REFABRICATE WITH MATCHING MATERIAL SUCH AS LONGLEAF PINE, PER MATERIAL TEST

7. NON-HISTORIC HALF WOOD SCREEN: REMOVE.
8. PROVIDE SHOP DRAWINGS FOR ALL REPAIRS, VERIFY DIMENSIONS AND SITE CONDITIONS, IDENTIFY SCOPE OF REHABILITATION OF WINDOWS INCLUDING ITEMS BEYOND REPAIR REQUIRING RECONSTRUCTION. IDENTIFY THERMAL AND MOISTURE PROTECTION FOR WINDOW INSTALLATIONS TO EXISTING OPENINGS.

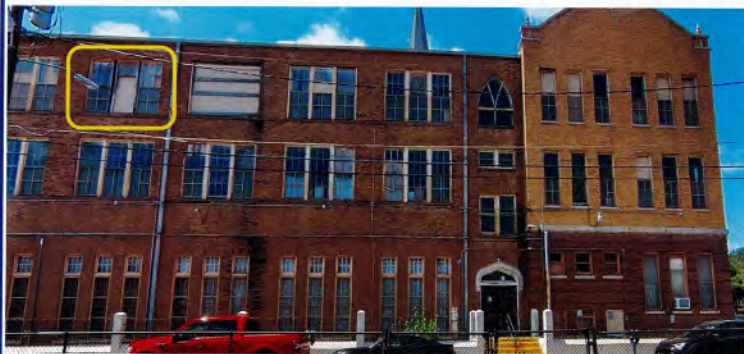
A. NORTH ELEVATION — WINDOW LOCATION

TYPE 'E2' — EN303 IS ONE (1) OF THE FOUR (4) SETS OF TYPE 'E' WINDOWS AT THE (3RD) FLOOR WHICH ARE **SEVERLY COMPROMISED BEYOND REPAIR** TO EFFECTIVELY PERFORM ALL THE FUNCTIONS OF THE WINDOW. WE RECOMMEND SALVAGING ITS COMPONENTS TO RESTORE THE TYPE 'E' SETS ON SOUTH ELEVATION OVER THOSE ON THE NORTH.

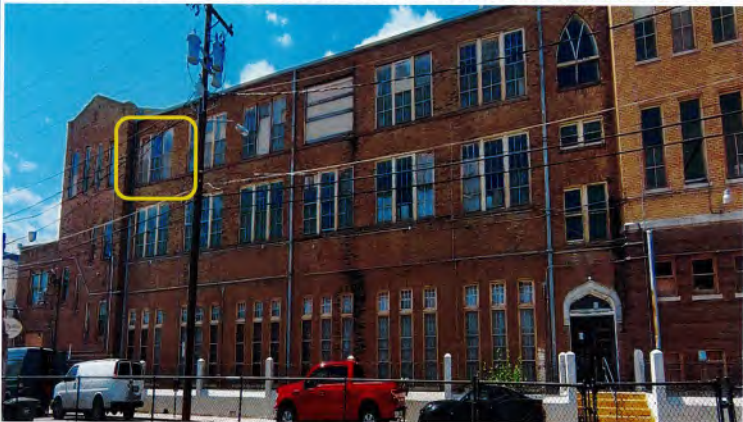
A. NORTH ELEVATION — WINDOW LOCATION

TYPE 'E3' — EN301 IS ONE (1) OF THE FOUR (4) SETS OF TYPE 'E' WINDOWS AT THE (3RD) FLOOR WHICH ARE **SEVERLY COMPROMISED BEYOND REPAIR** TO EFFECTIVELY PERFORM ALL THE FUNCTIONS OF THE WINDOW. WE RECOMMEND SALVAGING ITS COMPONENTS TO RESTORE THE TYPE 'E' SETS ON THE SOUTH ELEVATION OVER THOSE ON THE NORTH ELEVATION.

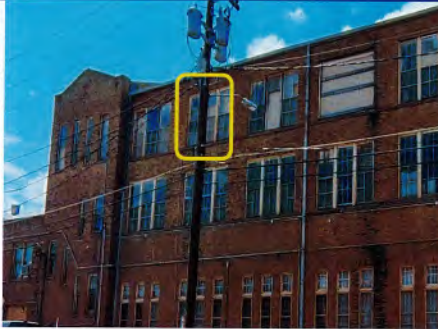
A. NORTH ELEVATION — WINDOW LOCATION

TYPE 'E3' — EN302 IS ONE (1) OF THE FOUR (4) SETS OF TYPE 'E' WINDOWS AT THE (3RD) FLOOR WHICH ARE **SEVERLY COMPROMISED BEYOND REPAIR** TO EFFECTIVELY PERFORM ALL THE FUNCTIONS OF THE WINDOW. WE RECOMMEND SALVAGING ITS COMPONENTS TO RESTORE THE TYPE 'E' SETS ON THE SOUTH ELEVATION OVER THOSE ON THE NORTH ELEVATION.

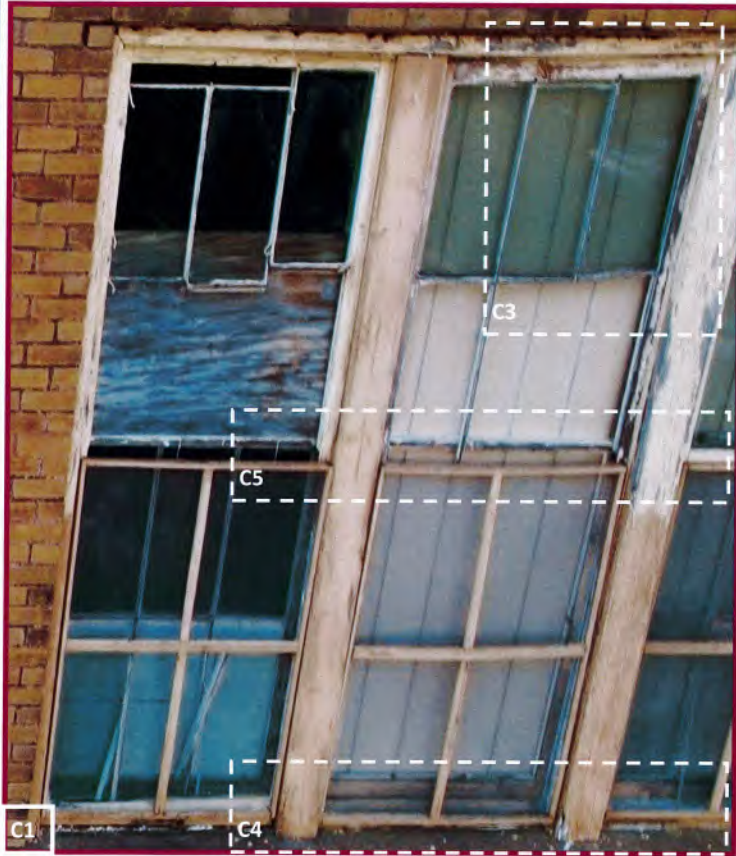
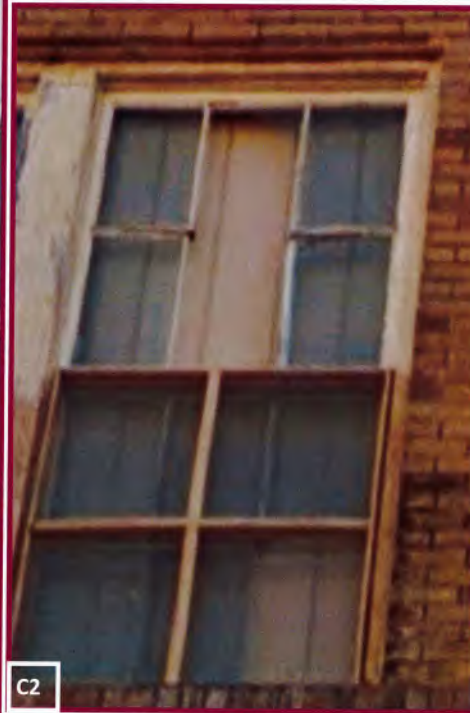
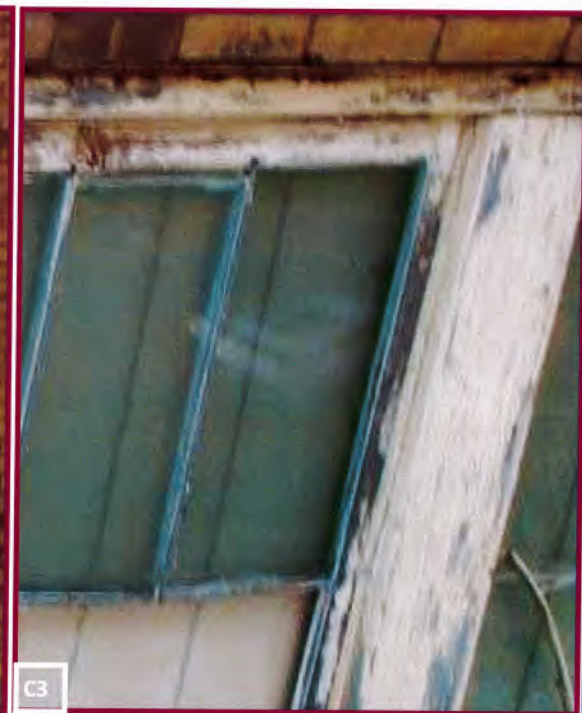
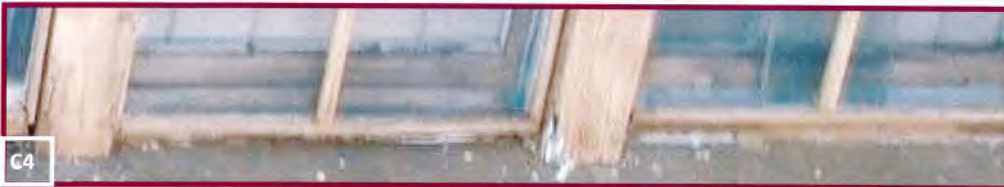
C. WINDOW DETAILS (HEAD, MULLION/RAIL, JAMB, SILL)

SUMMARY OF NORTH TYPE 'E' WINDOW SETS AT 3RD FLOOR: SEVER DAMAGE AT MAJORITY OF THE SETS AND MAJORITY OF THE 18 DH UNITS.

SINCE SOUTH TYPE 'E' ARE IN BETTER CONDITIONS HAVING HAD BETTER PROTECTION FROM THE WEATHER, THEN SALVAGED MATERIAL COULD BE USED FOR THEIR RESTORATION.
